Emergency Coastal Protection Works – Practical Lessons For The Future From The Past

Angus Jackson¹

¹Principal Engineer, International Coastal Management

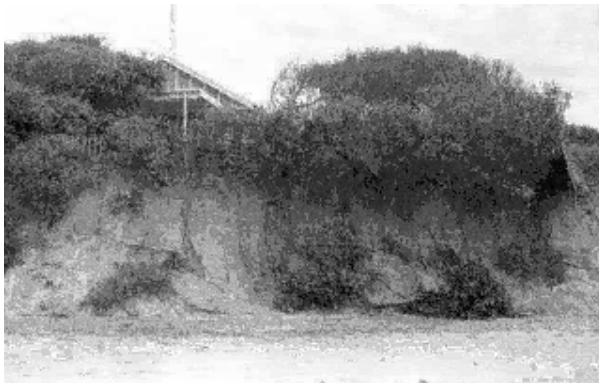
Figure 2 Dune cut

The 1967 cyclones, 7 of them, back to back, caused extensive damage to all of the southern Queensland beaches. In areas with wide well vegetated dunes, the erosion was slowed but eventually the dunes collapsed during the batterings on every high tide (Figure 2).

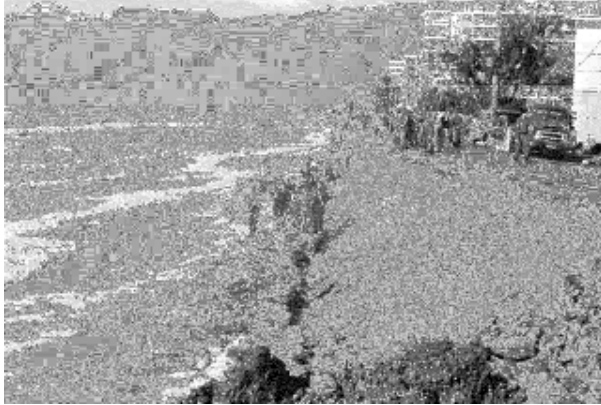
Figure 3 Surfers Paradise Esplanade 1967

It was not just private beach houses and lifesaving clubs that were threatened - the public esplanade roads that had been designed well back from the beach by the early State Government planners were severely damaged. This meant that services such as power and water were cut and access to properties was cut off. Surfers Paradise esplanade is shown in Figure 3.

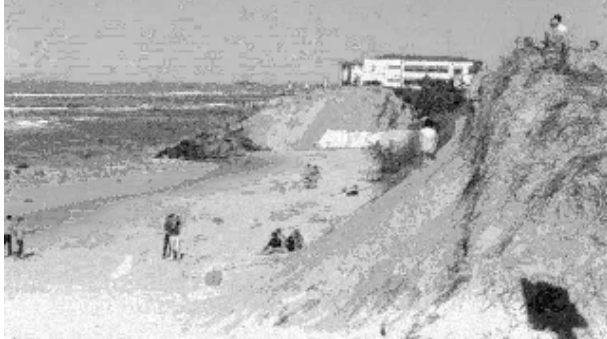
Figure 4 Erosion without protection compared to with adequate protection .

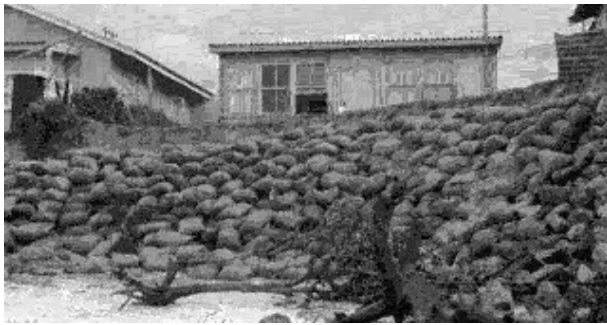
The army were dispatched to deal with the disaster. They brought with them their familiar tool, hessian sandbags (Figure 3 and 5). Larger plastic fertilizer bags were also used by Council and residents but proved less effective due to their low coefficient of friction. Gold Coast City distributed sandbags to owners who filled them using readily available sand, from their yards.

Figure 5 Sand bags

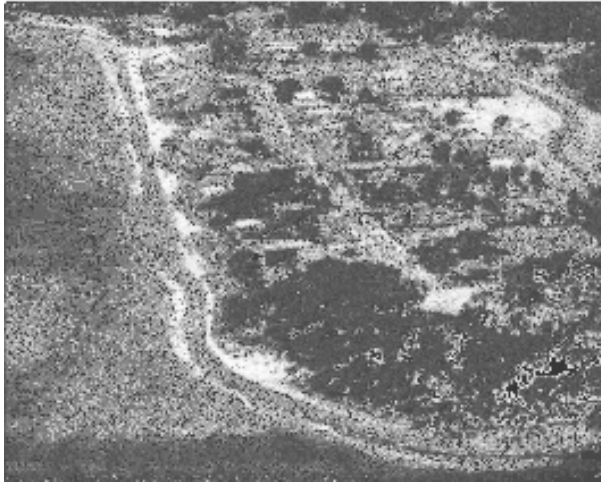
Other areas of the Queensland coastline have had similar experiences to the Gold Coast and well constructed emergency walls are common along the Queensland coastline. The emergency rock wall (Figure 6) constructed by Noosa Shire saved Hasting Street while major beach improvement works were designed and implemented. The wall is now buried at the back of the beach where it will limit future severe erosion events, when they next happen.

Figure 6 Noosa rock wall 1972-73

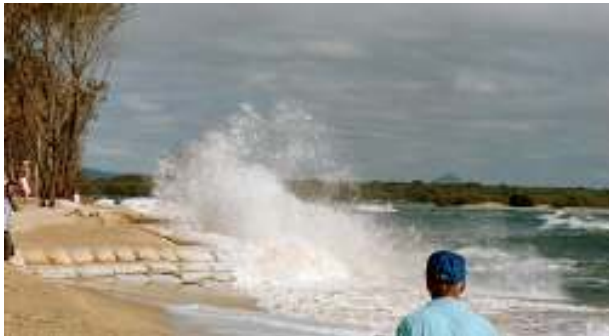
Sand is a readily available material along the coast and the use of sand bags has also evolved. In recent times, Maroochy Shire used modern “sand bags” to protect their caravan park (Figure 7). This allows the works to be done quickly and easily removed after the event, if required.

Figure 7 Maroochy sand bag wall
