# A review of the use of geotextile erosion protection structures in the coastal zone

Paul O'Keeffe<sup>1</sup> and Heather O'Keeffe<sup>2</sup>

<sup>1</sup> GHD Pty Ltd - Brisbane GPO Box 688 QLD 4001

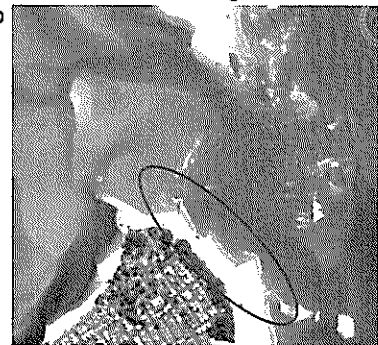
The project consisted of four groynes, perpendicular to the coastline and spaced about 90m apart, located where the southern bank of the river intersects with the beach, refer Figure 3.

The length, location, and orientation of the groynes was model tested at the Queensland Government Hydraulics Laboratory by WBM Pty Ltd. The Council decided that the groynes would be constructed with GSCs for a number of reasons and the GSC groyne structure was subsequently designed by International Coastal Management.

Four groynes comprising 2.5m<sup>3</sup> (5t) geotextile sand containers in a pyramid shape were constructed. The geotextile containers were manufactured from a composite UV stabilised non woven staple fibre needle punched geotextile. Filling for the containers was to be sourced from the beach. The design included an additional lower layer of containers to provide scour protection for the end of the groynes.
