# Woorim Beach Bribie Island and the revolutionary "FFF dune fence".

David Percival<sup>1</sup> and <u>Ian Bell</u><sup>2</sup> <sup>1</sup> President Friends of Woorim Beach <sup>2</sup> Project collaborator and inventor

### ABSTRACT

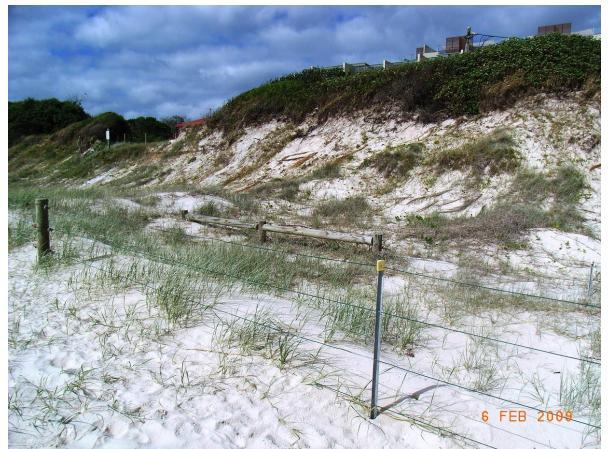
Figure 4 Partial recovery of Woorim Beach following the severe erosion of 2005/06.

As shown in Figure 4, the foreshore, although restored, has reduced resilience against future erosion due to the sparse vegetative cover. The original fence erected to exclude trampling has become completely buried, requiring the construction of a second fence which is also becoming buried. This

results not only in loss of function and investment but also creates a danger with partially exposed wires and the sharp ends of steel pickets.

As shown in Figure 4, traditional fences are not suited to the beach and become buried, eventually rendering them useless and a considerable waste of expenditure. Buried or semi-buried fences are also dangerous. Clearly a completely different approach is necessary in fencing along the foreshore.

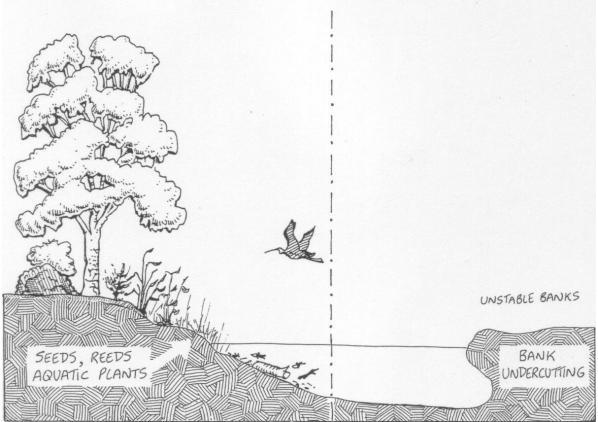
Figure 11 The role of vegetation types in protecting both the top and the toe of the stream bank from erosion and undercutting.

Figure 11 shows the important role of vegetation in ensuring stream bank stability. The upper bank is stabilised by larger vegetation – trees and shrubs, while much smaller and seemingly less significant species such as reeds and aquatic plants stabilise the toe of the bank. However whilst these small species might seem insignificant,

they play a crucial role in preventing the commencement of stream bank erosion by the process of toe erosion and undercutting that can eventually undermine the larger vegetation (trees and shrubs) on the top of the bank. It's the same with dune systems.

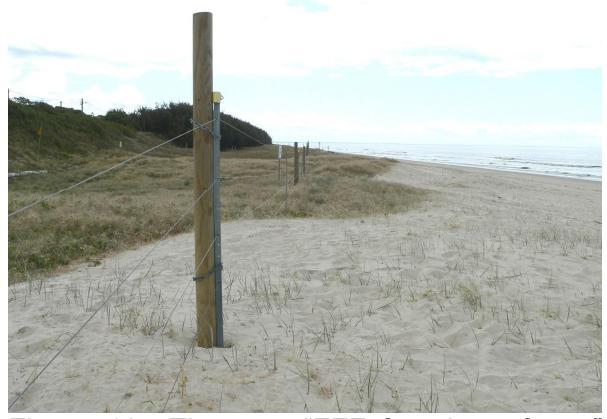
Figure 12 The new "FFF foreshore fence" design as adopted by the project.

This new fence (refer Figures 11,12,13,14) enables adjustment of fence height to suit the changing shape of the dunes by sliding the steel star picket either up or down the wooden post after releasing the chain retaining screws. Four wires are adequate to provide exclusion zone. It is an recommended that suitable signage be attached centrally in each span to explain the purpose of the fence and to highlight the

presence of the wires. Visible indicators such as streamers are an option.

Wires can be retensioned as necessary by adjusting the ratchets at either end of the span. The timber posts are 4 metres long, pointed and driven 2 metres into the sand. Because only minimal wire tension is required and with the posts 2 metres into the sand, there is no need for a conventional double post end strainer assembly. However a 600 x 150 x 50 mm thrust block is required to be buried approximately 500 mm deep against each end post to provide additional support against the strain of the wires. This is also required at any change of direction. Post spacing is nominally 25 to 50 metres and at the main high and low points along the foreshore. With longer post spacings it is recommended that droppers be used to maintain wire spacing. Closer spacing of posts has the benefit of possibly avoiding the need for droppers.

The alignment of the fence is chosen with the posts located on an existing rise or dune formation with the intention of commencing sand reclamation and dune formation towards the sea. Posts must be above maximum high tide level such that the buried portion of the posts is never in saturated sand as this would result in loss of rigidity.

As sand becomes deposited following the resultant advance of stabilising grasses the shape of the dunes will change and some posts will become partially buried. When there is insuffient space on the timber post to continue to raise the attached steel picket, the timber post can be jacked up as required. However, a minimum of two metres depth

must be maintained. Similarly if some posts become more exposed they can be re-driven to their original depth, however deposition rather than erosion will be the normal trend.
