Returning the tide to East Trinity: an acid sulfate soil remediation case study and lessons for the future

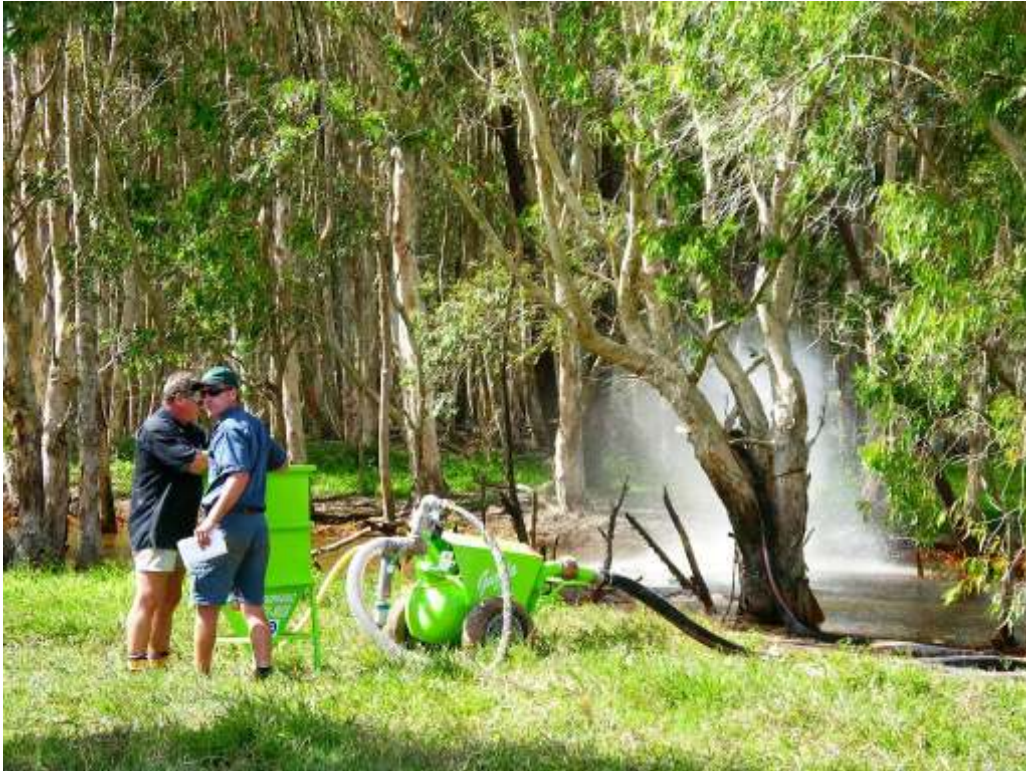
Photo 1

This water treatment machine is light-weight and highly portable making it useful for getting into boggy acidified areas to treat drains that larger equipment cannot get to. This unit also sucks acidified water from the drain and mixes it with hydrated lime $[\text{Ca}(\text{OH})_2]$ before returning the high pH slurry to the drain.

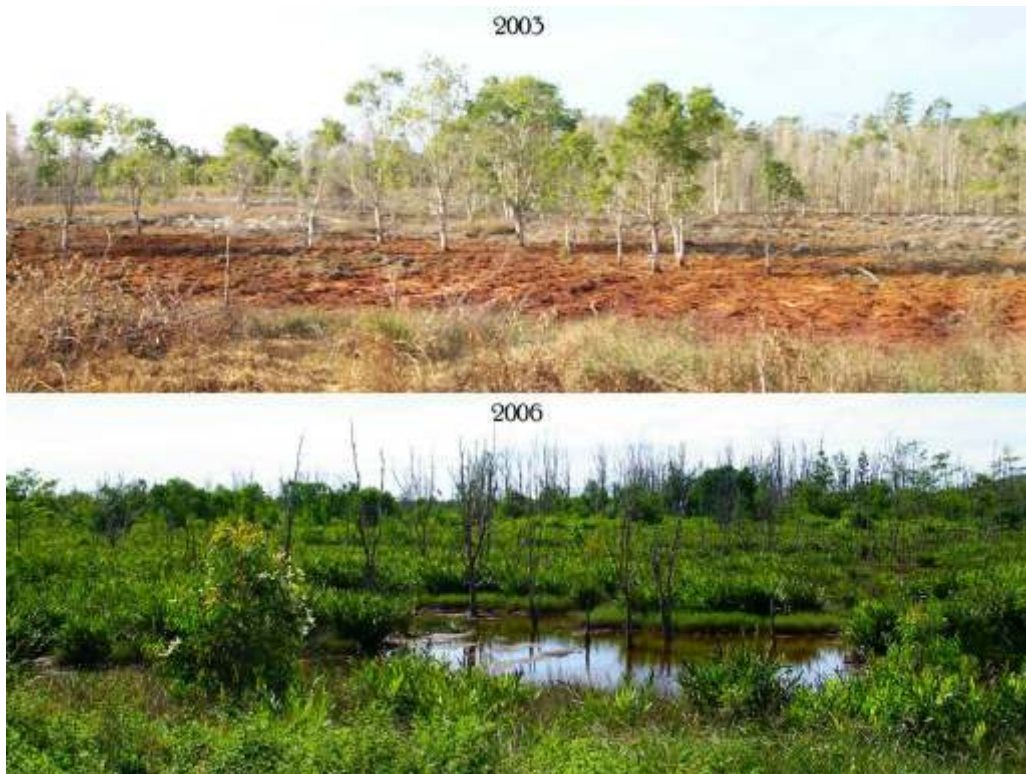
Photo 2

This area receives consistent tidal inundation and the change from the acid-affected terrestrial vegetation (*Melaleucas*, dead grass and iron staining) to marine vegetation (mangrove fern and saltwater couch) is obvious.
